DBRG NEWS

DBRG Newsletter No. 156
2024/1 January 2024

Dating of the very unusual roof at Gate House Farm, Newchapel.

Three-quarter bridled joint unusually used to cover the ends of cross beams.

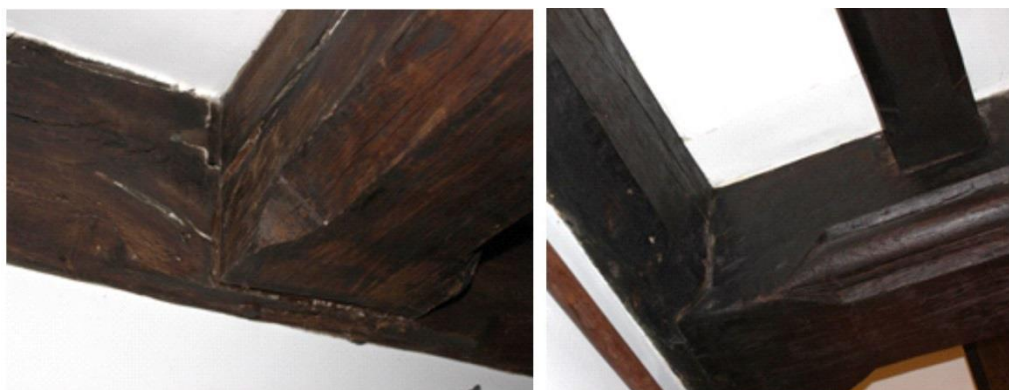
Intersection of axial beams with mid-ties, left image is north side of B, right image is south side C.

The ground floor bay A-B has an axial beam chamfered on both sides with a curved-step stop, the end of the stop is neatly run out. This chamfer stop is matched on the north face of transverse beam B with the chamfer on the transverse beam being interrupted where the axial beam joins into it. The ceiling joists are 140mm wide x 110mm deep and are not chamfered, their ends are sat upon the girding beam. There are no stave holes or pegs for a partition beneath the mid-tie B. The post in the middle of A-A' has pegs either side for a potential window

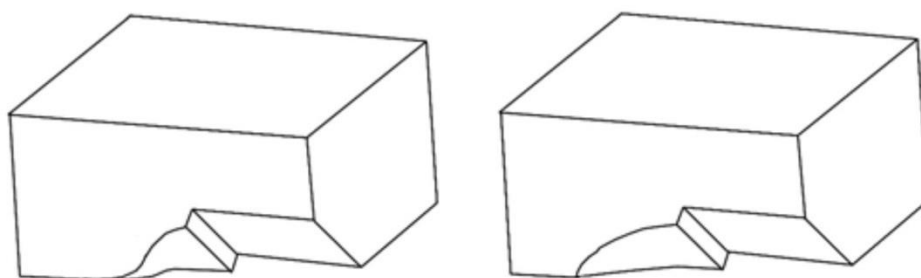
Mid-tie chamfer stops, left is mid-tie B, right is mid-tie C.

Bay C-D has an ornately moulded axial beam and joists with curved-step stopped chamfers, the ends of which are sat upon the girding beams. Mid-tie C has a deep chamfer, but unlike the north face of mid-tie B the chamfer is not interrupted for the axial beam which obscures it. This chamfer has a curved-step stop at the west end but has no stop at the east end where it runs up to the post at C'. Several of the eastern ends of the joists clash with the down-braces and studs above the girding beam C'-D'. Mid-tie D has a chamfer for a door against D (aligning with the door opening beneath girding beam X'-Y'), the remainder of mid-tie D has mortices and stave holes beneath it for a partition faced to the north.

The mid-tie of frame C with a chamfer that runs into the post at C' whilst it has a stop before post C, and the chamfer not being interrupted where the axial beam joins the mid-tie does not match the carpentry of bay A-B. The style of chamfer stops are also different. Thus, it is likely that only bay A-B was originally floored, the narrower bay B-C was most probably unfloored and the rafter numbering is likely to indicate the presence of a louvre within this bay.

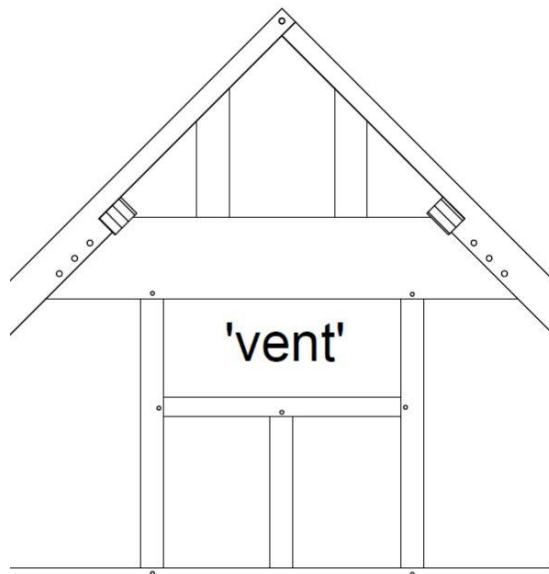
Detail frame A
Upper Centre

The entire roof A-D is smoke blackened. Above tie-beam A there are pegs for two queen struts, within the attic there is a 'vent' between

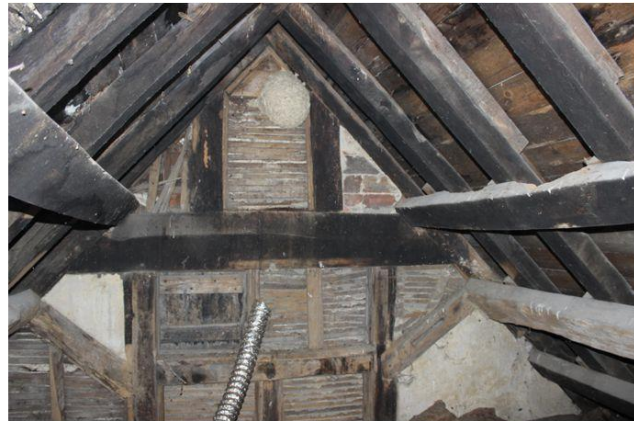
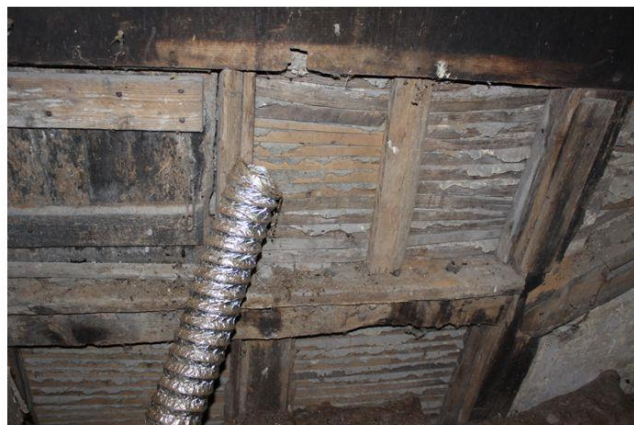
Top. Frame A from south
Below. Detail around 'vent'

these struts. The underside of the collar indicates the original form of this opening with a central diamond mullion with rectangular mortices either side. The west side of the 'vent' has a sooted panel of boards inserted into it which has a chain attached on its right side. Above the east two-thirds of the vent there is a cleaner area on the collar indicating a timber was there whilst the collar was still being exposed to smoke. On the sill of the vent a thin un-sooted timber has been nailed which has mortices for three small diamond mullions either side of the central large mullion. Whilst frame A has two queen struts, frame D has a single crown-strut supporting the collar.

Underside of
collar

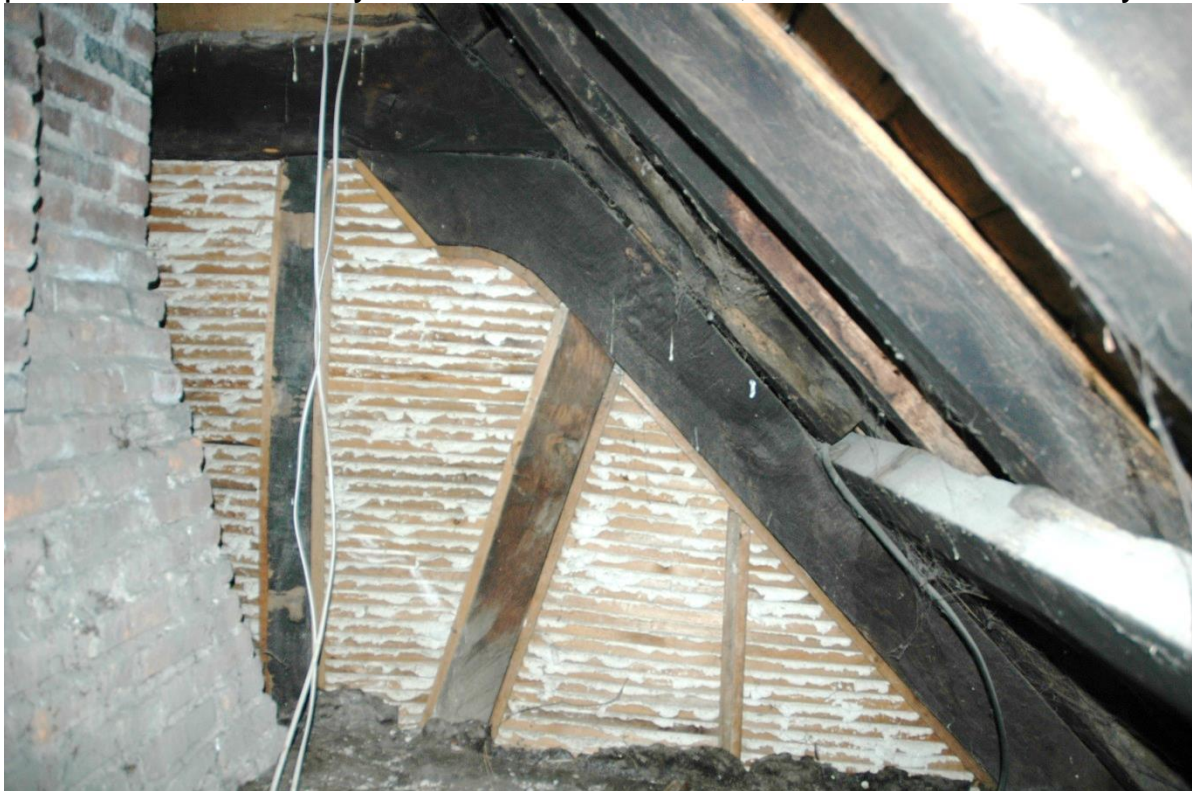
North side of frame C, showing the clasped lower purlin

are clasped by raking queen struts that are pegged into the tie-beam and the principal rafters are trenched over the purlins; frames C and D have the lower purlin clasped between the principals and a straight timber abutting the principal rafter between the tie-beam and the collar and pegged into both. Andy Moir has termed these short principal trusses.

The roof has a 45° pitch and is clasped side-purlin with double purlins, the upper purlins are clasped by the collar in all the frames although frames A & D have deeper collars with three pegs attaching them to the principal rafters, whilst frames B & C have shallower collars with two

pegs. The upper purlins have straight wind-braces beneath them to each of the principals, which are diminished above the collar. The lower purlins are secured by two different methods, in frames A and D they

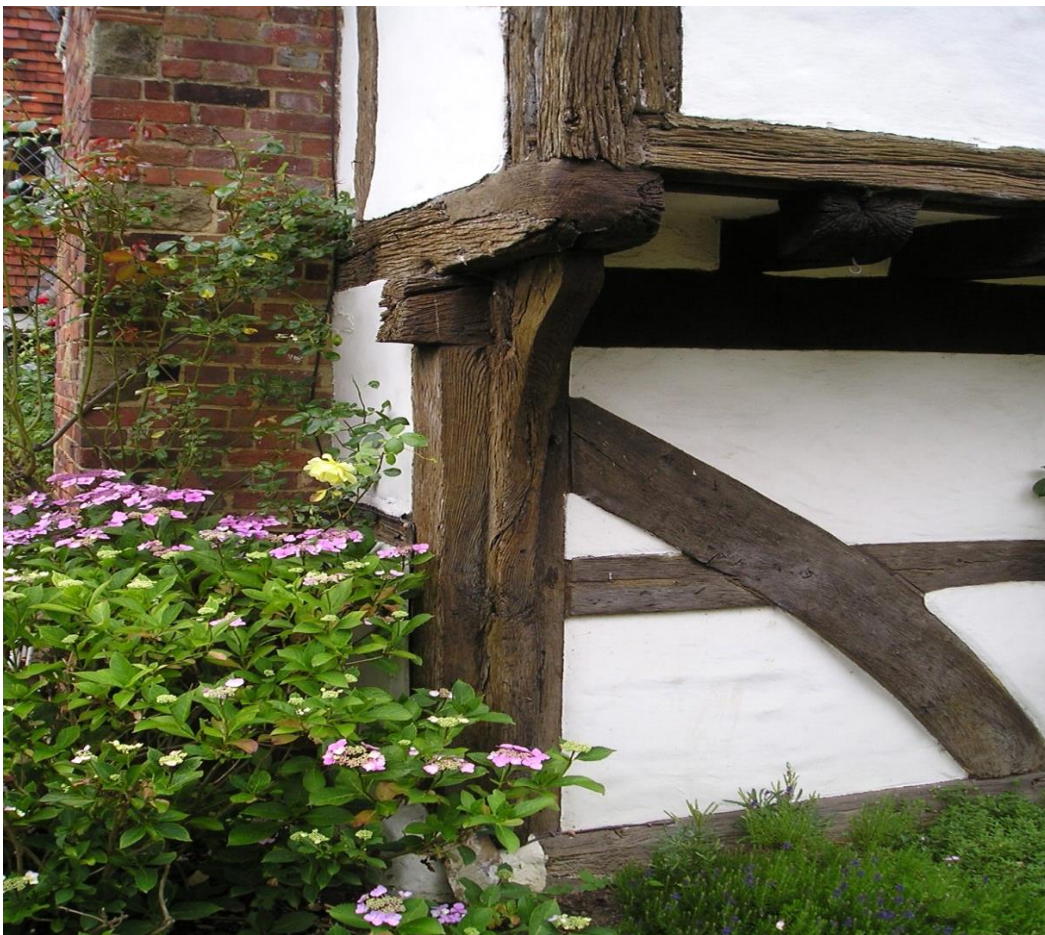
This joint used this way has not been recorded previously in Surrey or Sussex* which is why I have reported it. The same joint is sometimes used to join a corner first-floor post to a jetty plate, as in the example from Cogmans, Burstow (Dendro 1476), illustrated below.

Cogmans, Burstow (1476). Jetty plate bridled to first floor post.

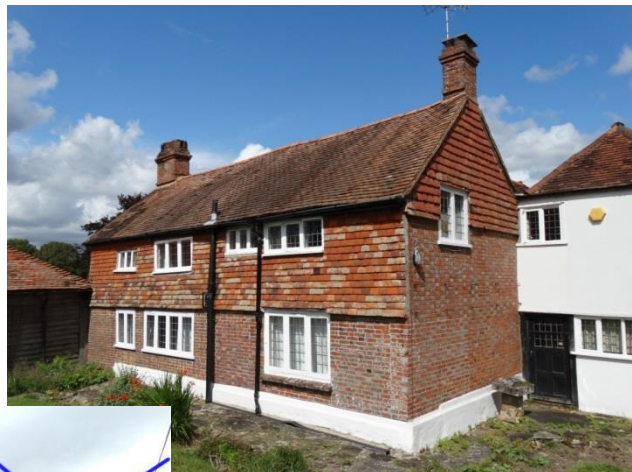
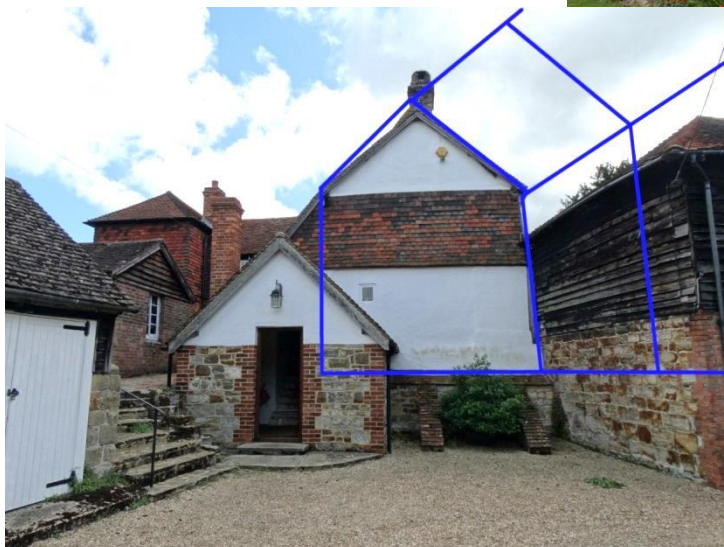
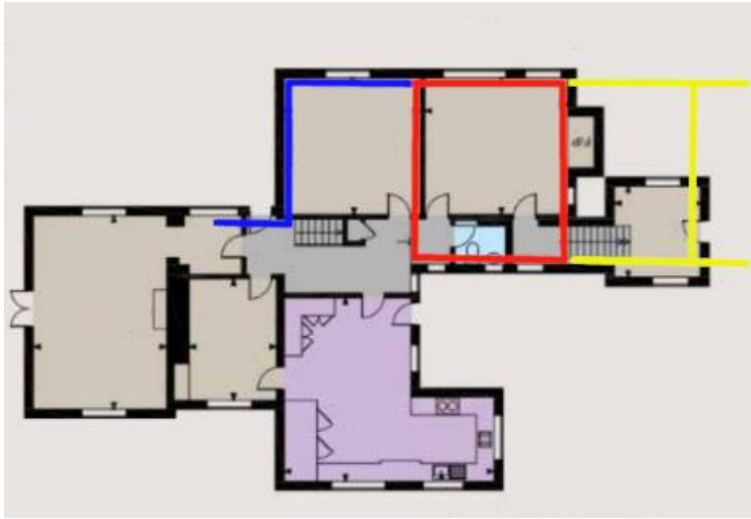
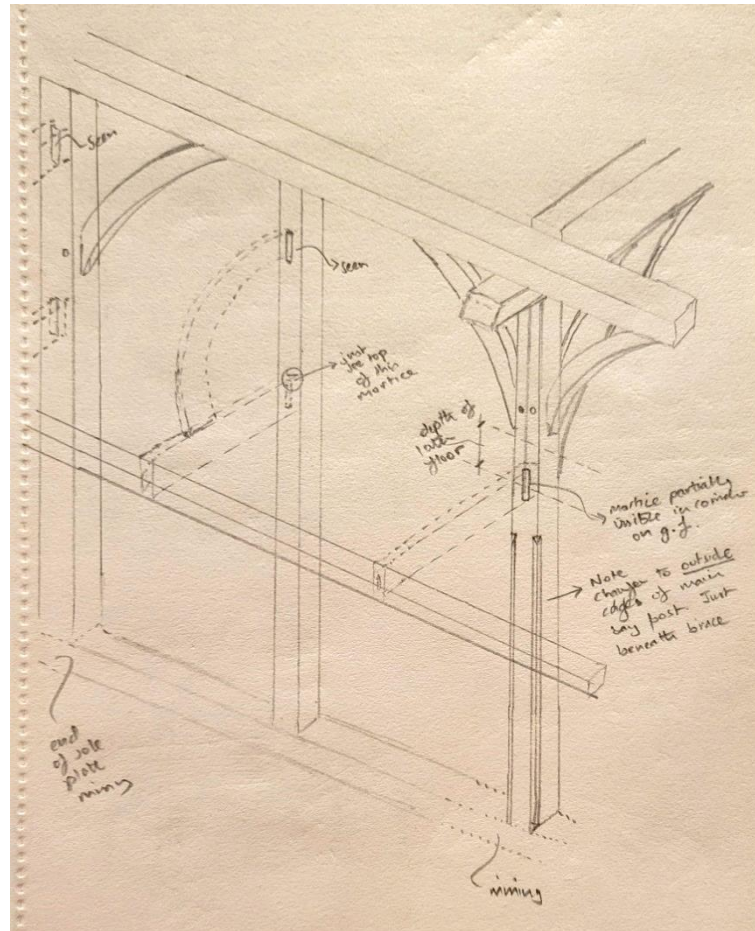
The open truss consists on one side of an aisle post with the tie beam extending beyond the outer face of the post with the arcade plate on top of it (reversed assembly). Opposite this is a curved principal (cruck) connected into the tie beam with a wall plate on top of it. A

lower wall plate is provided at the lower end of the rafters directly carried by the cruck. There is no evidence for a crown post so it was a sans purlin (common rafter) roof. Later another tie beam was provided on top of the original. At the high end the deep moulded dias beam has the mouldings unusually continuing down the posts on each side. Above the dias beam the wall is divided by a central stud on each side of which are a pair of diagonal timbers meeting at the top of each side area. The crosswing has a crown post roof and is

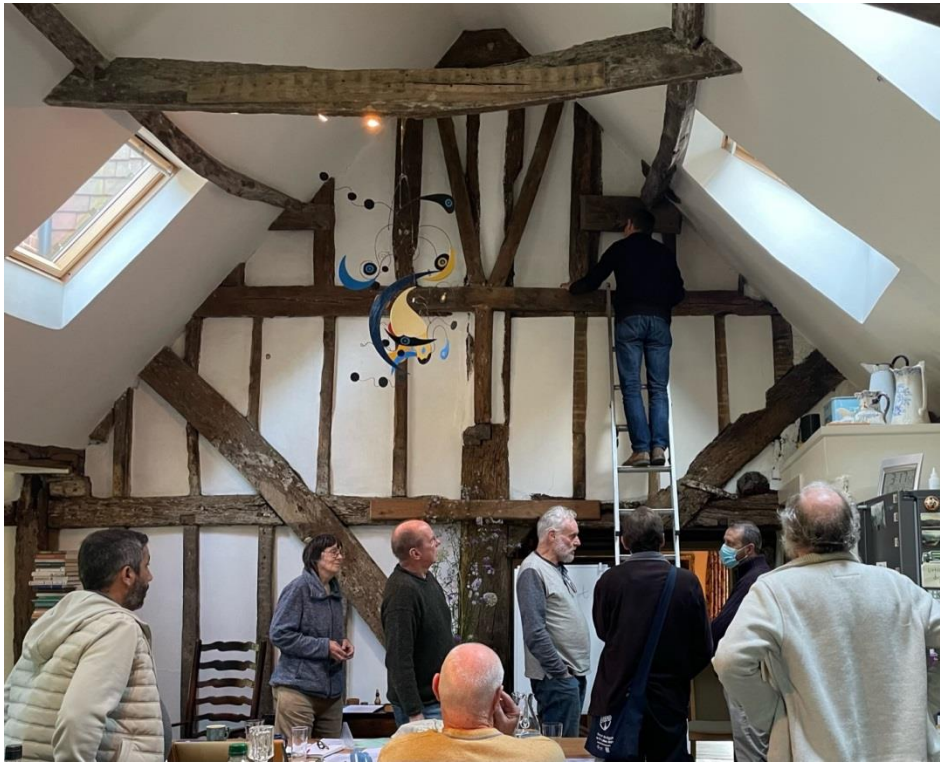
Eager
DBRG
members
admire the
long
passing
braces and
investigate
the framing

The building, with crown posts, passing braces and quadrant mouldings on timbers, was dendro-dated to 1366. Three ranges, A, B and C were built at that time, in an unusual z pattern, with each range being at right angles to its larger neighbour. (See floor plan.) It was floored throughout with the rooms at first floor level open to the rafters. No evidence has been found of a hall attached to these first floor rooms. A small archaeological dig found nothing conclusive.

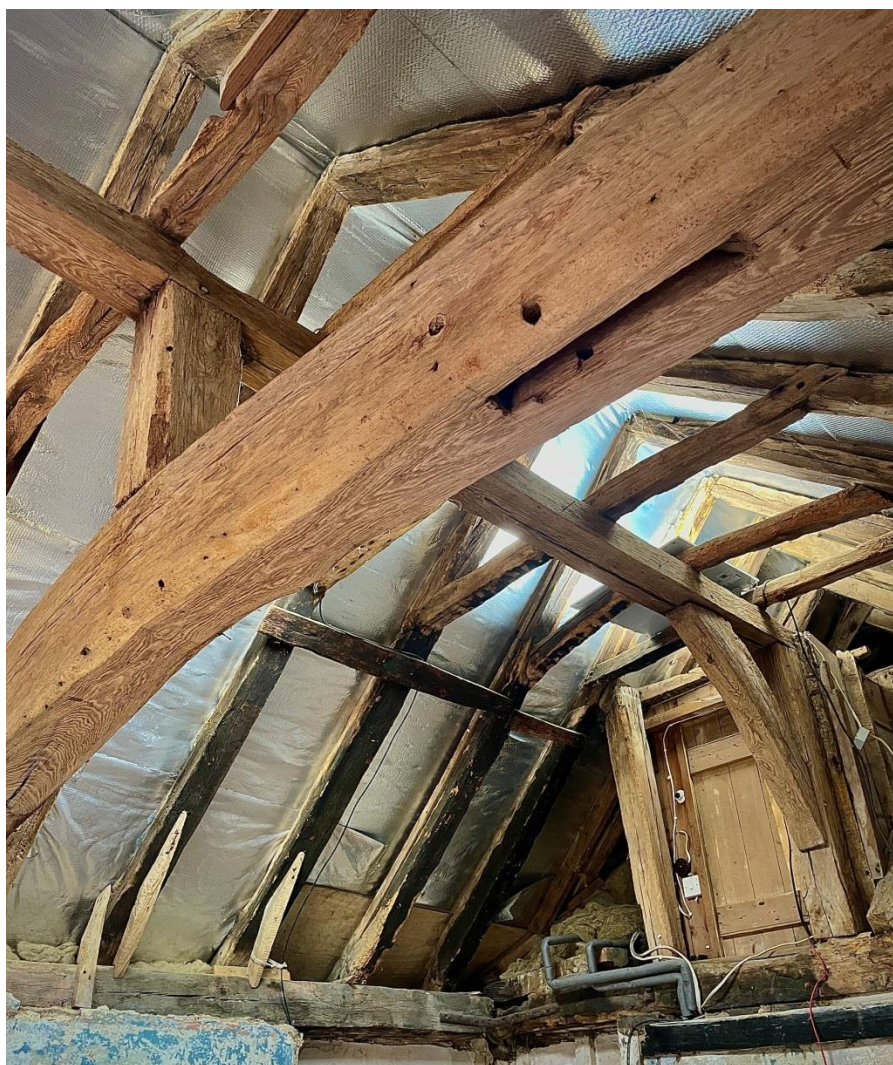
Newly exposed roof structure of Range B, showing smoke blackening in one bay.

One section of the roof timbers in Range B of the building has smoke blackening whereas the other rafters, tie beam, crown post etc are pale and beautiful as when first built. The blackening is contained within one quarter of the roof. The accepted view so far had been that the smoke blackening had been caused by an accidental fire.

The DBRG experts on the visit were confident that the pattern of smoke blackening and some nail holes were evidence of a purpose-built smoking chamber (for meat etc) adjacent to a chimney. By useful coincidence, just after the visit, we were having a wood burner installed in that chimney and the register plate was removed. It was possible to put a ladder up and see a clear vertical gap between the large stone blocks of the structure that took the smoke into the smoking chamber. It was very satisfying to reach a firm conclusion on this issue. Now we want to find out more about smoking chambers!

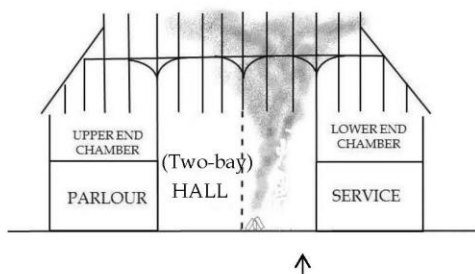
Section of a two-bay open-hall house

Cutaway drawing by Martin Higgins

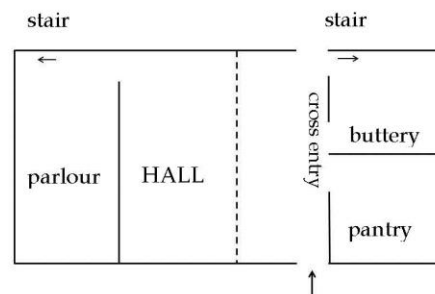
Plan of a two-bay open-hall house
